CANADIAN FORCES FLIGHT SAFETY INVESTIGATION REPORT (FSIR)

FINAL REPORT

FILE NUMBER: 1010-C-FARD (DFS 2-4-2)
DATE OF REPORT: 07 July 2006

AIRCRAFT TYPE: Schweizer 2-33A Glider
DATE/TIME: 31 1303Z October 2004
LOCATION: Trois-Rivières Airport, Trois-Rivières, QC
CATEGORY: "B" Category Accident

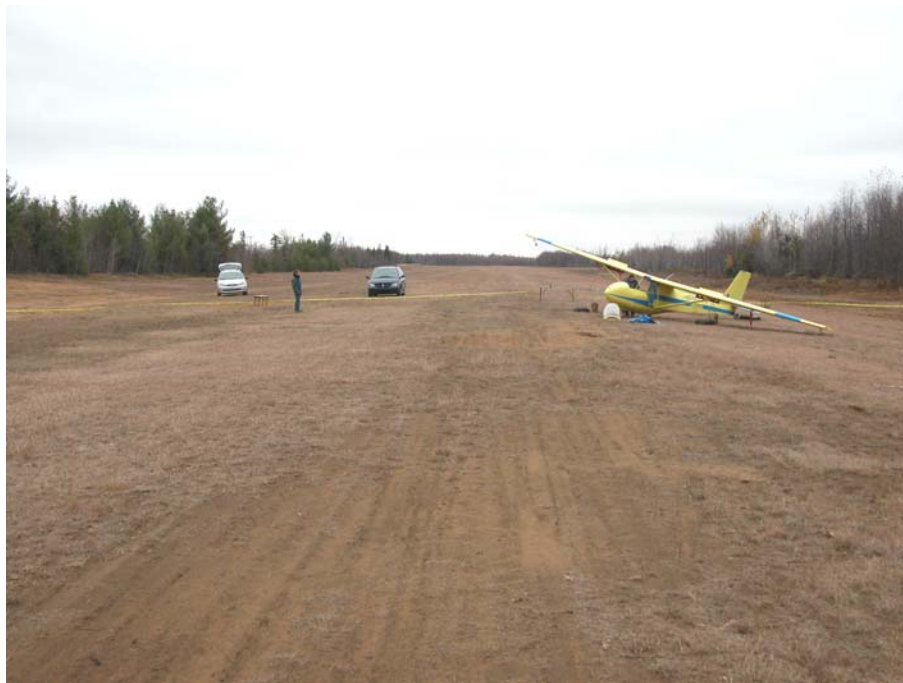
15 mph slower than required throughout the manoeuvre. The SP initiated the turn to base leg late. This combined with the strong crosswind component resulted in a lateral overshoot of the grass runway, which placed the aircraft in a difficult position to reach the intended landing area. The IP then took control while the glider was still on base and increased the bank to at least 45 degrees in an attempt to realign the glider with the grass runway. The grass runway was overshoot a second time and the glider was now heading towards nearby trees on the right side of the grass runway. The IP then banked left at a low height in an attempt to return to the runway. In close proximity to the launch point, the glider contacted the ground left wing first, followed immediately by the landing gear and tail of the aircraft. It skidded across the ground for approximately 30 meters bouncing on the right wing tip prior to stopping almost 130 degrees from the runway centreline (Photo 1).

The impact site was within the grass landing area, approximately 300 meters from the approach end of runway 23 and beside a line of trees along the right side of the runway. The aircraft nose was pointing approximately 130 degrees from the runway axis (centerline) opposite the launch point with the left wing resting on the ground. The wreckage was found in one piece with the exception of the canopy that had been removed by emergency response personnel. The left wing, landing gear and tail impact scars were easily discernable and within approximately 30-35 meters of the glider's final resting point, indicating a shallow angle low airspeed approach at ground impact. This was consistent with the glider's damage.

Photo 1: Final Resting Place

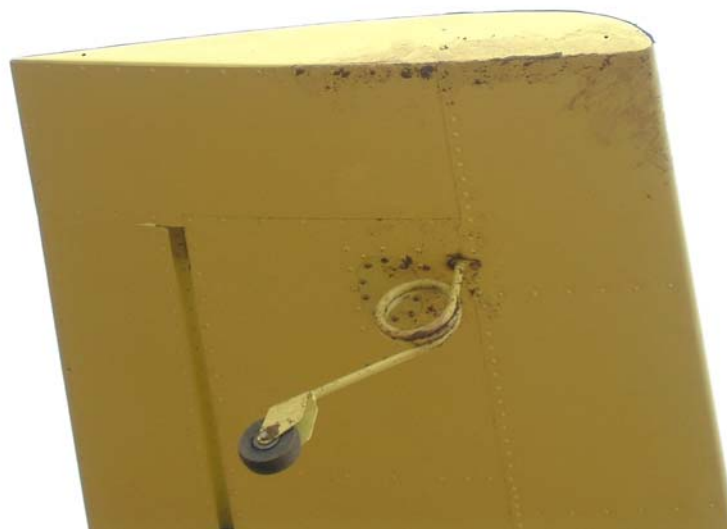
Photo 2: Right wing tip

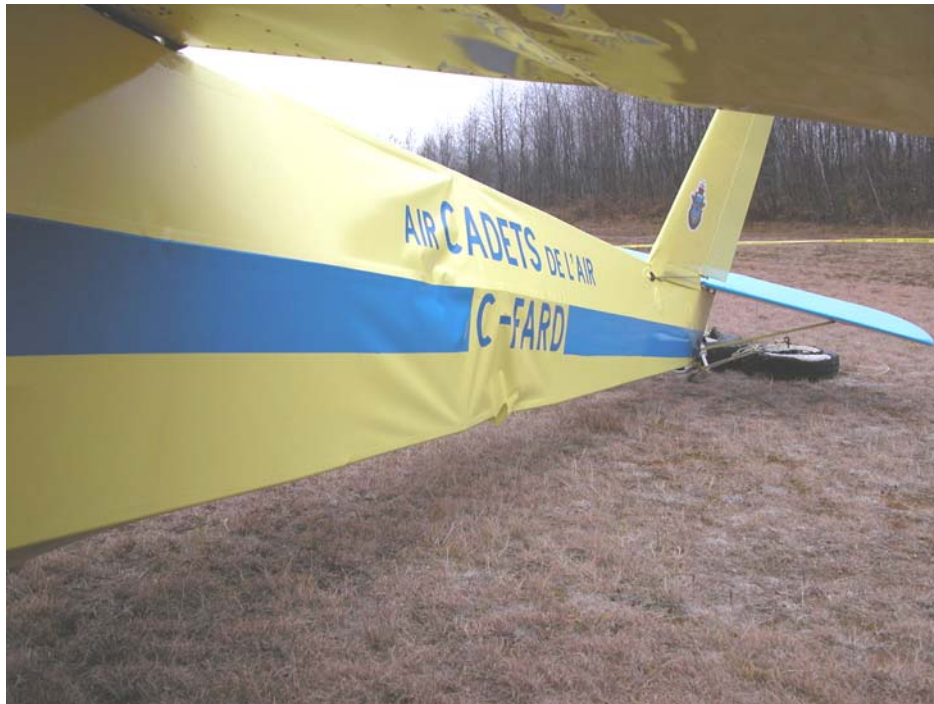
Photo 4: Left Wing and Fuselage damage

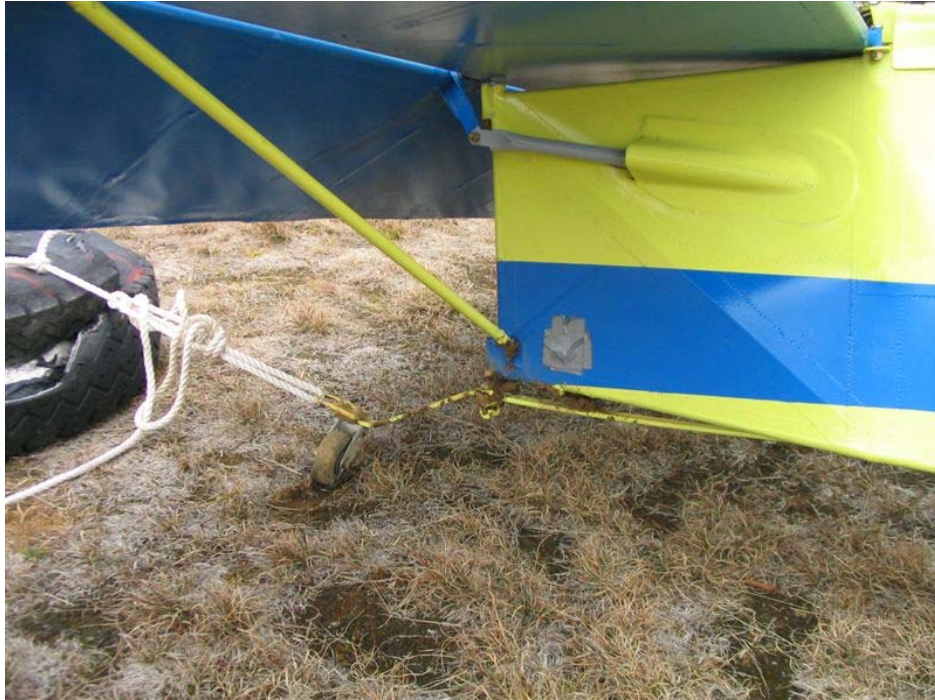
Photo 5: Tail leaf bracket damaged

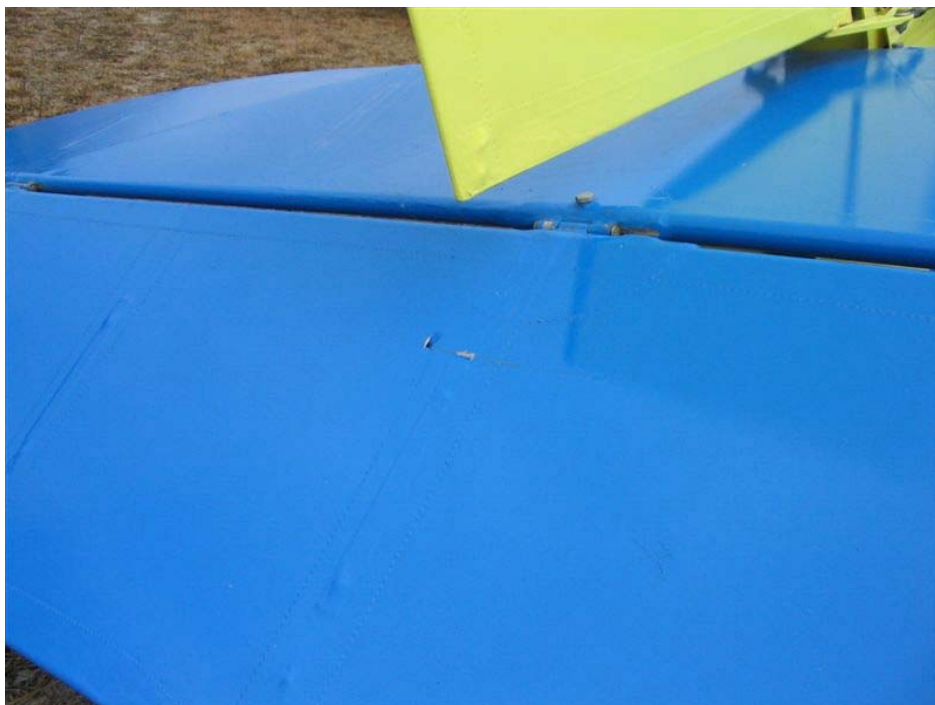
Photo 6: Rudder / elevator contact

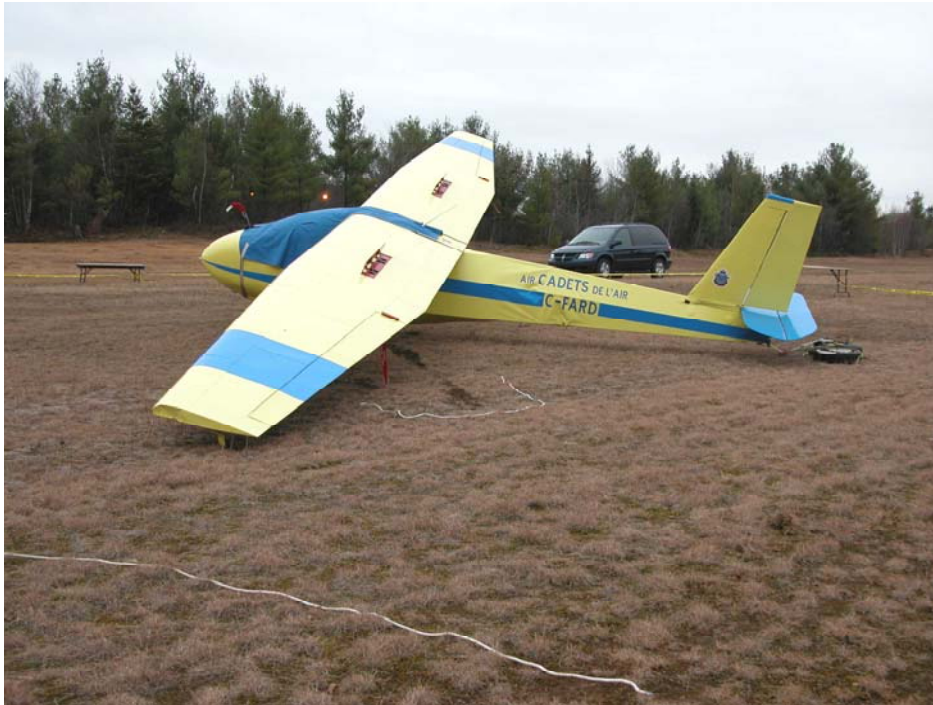
The spoilers were found in the extended position (Photo 7) and the rudder pedals were adjusted in the full forward position. The spoilers functioned normally when checked post accident. The cockpit instruments appeared to be functional.

The IP did not adjust the spoilers during the approach to land and they remained in the full open position until the final touchdown. The effect of the open spoilers would be to increase the rate of descent, create a slight change in pitch attitude, reduce airspeed, and increase the stall speed. Because the glider was below the desired altitude on final approach, the spoilers in the open position would have only aggravated the situation by decreasing the amount of time the crew had to align the aircraft with the grass runway.

Photo 7: Spoiler Positions

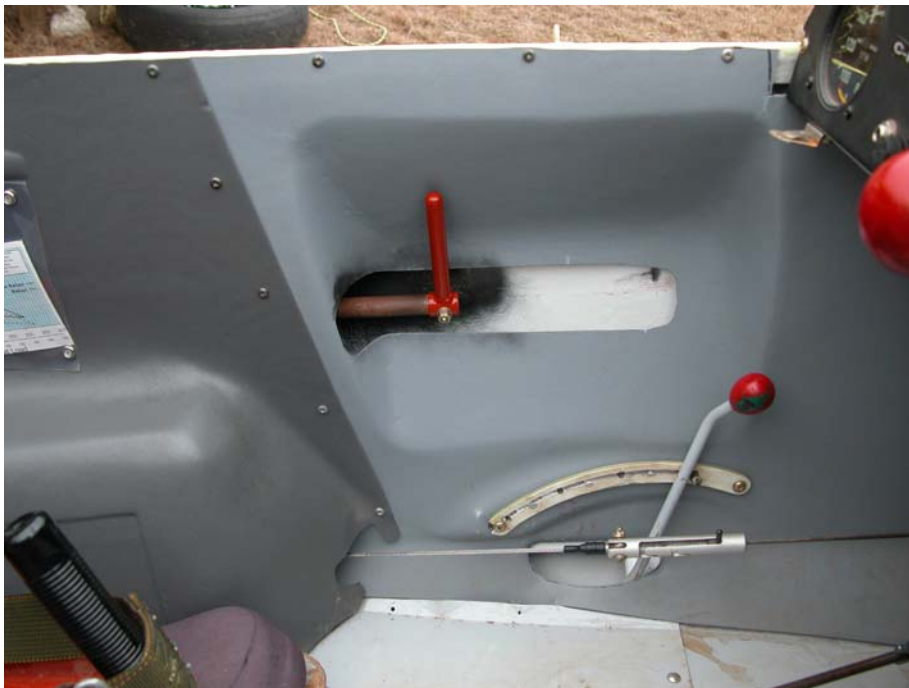
The crew harness straps appeared to be in very good condition for both the front and rear seats. Only the normal seat cushions were found in both seats, and no additional seat spacers were used by either pilot. The trim lever was found in the full forward position (Photo 8). The release knob and flight controls appeared to function correctly.

Photo 8: Spoilers and trim controls position
